Glenn Borkenhagen
P.O. Box 1525
Cody, Wyoming 82414

19 October 2018

Re: Environmental Assessment License – Section 3.0 Site Condition
Restoration of Property to condition prior to disturbance by Marathon

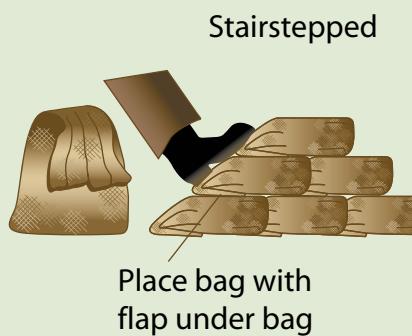
How to Use Sandbags

Filling

Filling sandbags is best done with two people. Fill half full with sand if available or local soil.

Sandbags will redirect water away from property but will not seal out water. Place sandbags with the folded top toward the upstream or uphill direction. Sandbags are temporary and will deteriorate after several months.
